Dewsbury STW - Wash water Booster Set Upgrades

The Service Solution

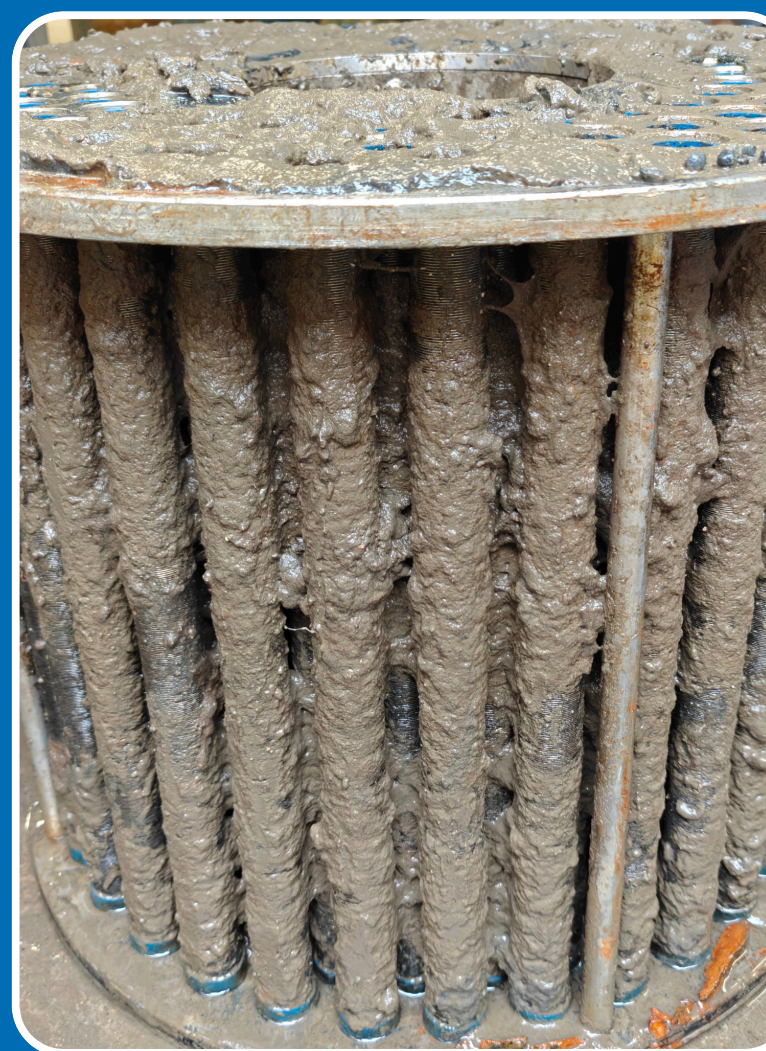
Site operatives were frequently required to perform manual interventions, leading to increasingly regular and disruptive out-of-hours call-outs. These interventions stemmed directly from recurring filter blockages, which caused critical process issues, including low flow rates and insufficient pressure. This core issue created a domino effect across the site, notably causing downstream spray nozzles to block, necessitating additional, time-consuming manual unblocking efforts and further impacting productivity.

Fouled Candles Removed From Filter

The BFUK service team implemented a multi-faceted solution to resolve the on-site filtration issues. A full inspection and mechanical overhaul of the automatic filter was conducted. Crucially, BFUK guided the site to transition from a reactive 'run-to-fail' approach to a structured preventative maintenance mindset, establishing a proactive maintenance schedule aimed at significantly reducing unplanned downtime events. For filter media management, an efficient candle cleaning strategy was implemented using a rotational 'swing set' system. This approach involves having a spare set of filter candles; while one set is operational, the used set is sent for professional off-site cleaning, thorough inspection, and performance grading by BFUK specialists. This rotation ensures candles are maintained to the highest standard and allows for quick exchanges, minimizing operational downtime on site.

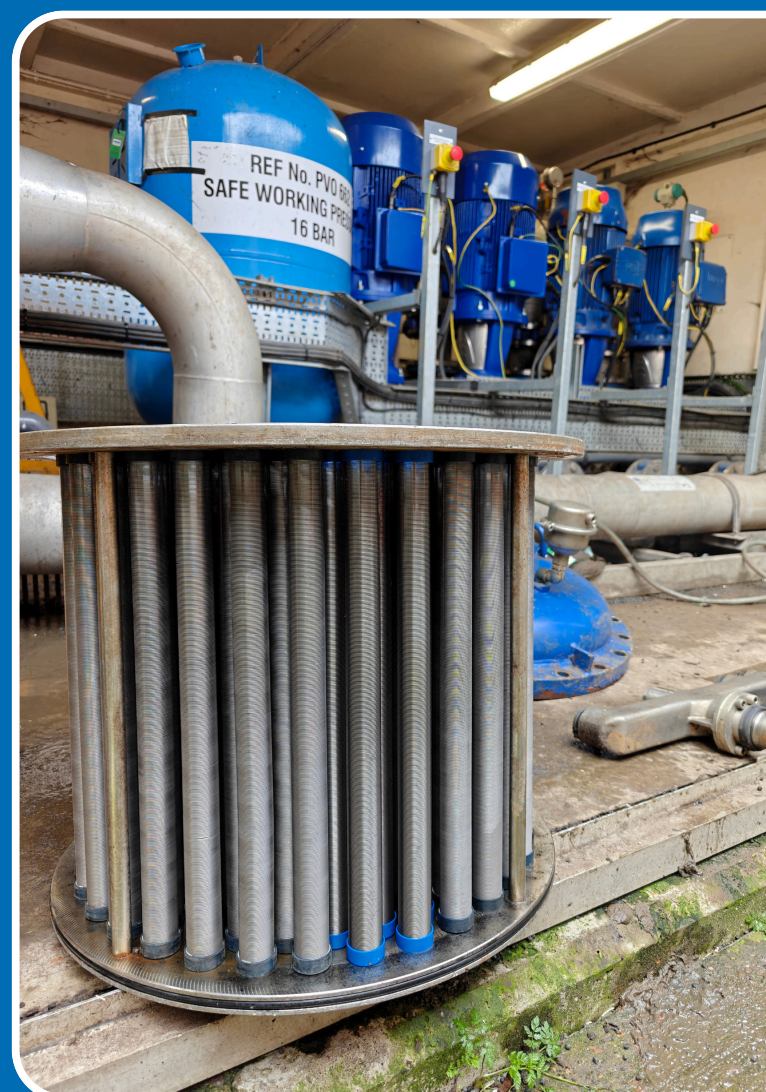
Clean candle set ready to install
