Crate washer – Nozzel protection Carlsberg, Frederica Denmark

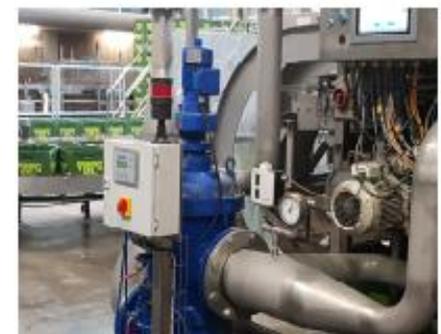
BOLLFILTER installed on crate washer

Two automatic filters Type 6.18 with a total of 300 m³/h have been installed for two years and showed great results. They filtrate the full circulated flow in the crate washing machine in each of the two treatment zones and cleanse water with high fibrous content.

Client	Carlsberg
System	1 x BOLLFILTER automatic Type 6.18 DN100 – 500 µm 1 x BOLLFILTER automatic Type 6.18 DN200 – 500 µm
